Manhole Inspection Summary

Manhole # S43AA_007MH

Insp Date: **6/30/08 10:13 AM**

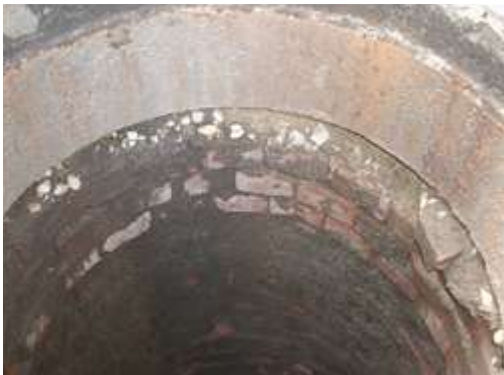
Defect 2

Frame Offset: **0.5** (in.)

offset frame

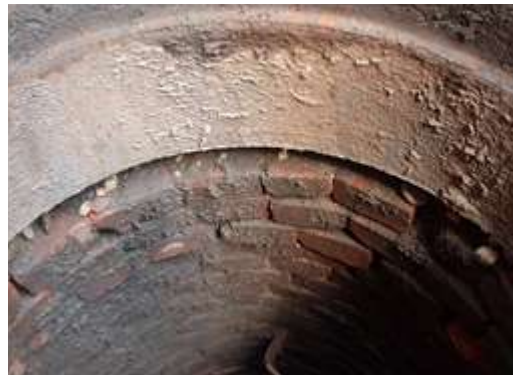
Defect 1

Condition: ☐ Sound ☐ Cracked ☐ Root Intrusion ☒ **Loose Brick** ☐ Deteriorated

Infiltration: ☐ None ☒ **Joint** ☐ Cracks ☒ **Mortar** ☐ Roots ☐ Wall

loose bricks

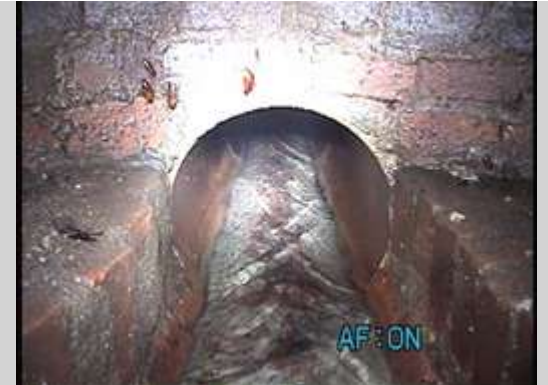
12 O'Clock Outflow

10 in. Circular Gravity Sewer
Pipe Out @ 12 O'Clock

Pipe Height: **10.8** (in.) Rod and Bar (Angled)
Pipe Material: **Clay** ☐ Pipe Lined
Invert Depth: **21.00** (ft.) Flow Characteristics: **Fast**
Deposits: ☒ None ☐ Mud ☐ Sludge ☐ Debris ☐ Grease
Silt Depth: (in.) Deposits Extent:
Infiltration: **None** Pipe Seal Cond: **Sound**

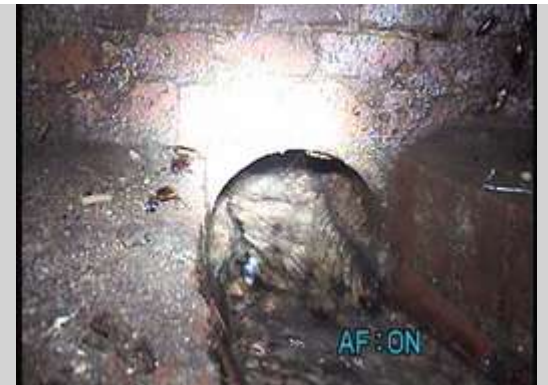
9 O'Clock Inflow

8 in. Circular Gravity Sewer
Pipe In @ 9 O'Clock

Pipe Height: **8.4** (in.) Rod and Bar (Angled)
Pipe Material: **Clay** ☐ Pipe Lined
Invert Depth: **21.10** (ft.) Flow Characteristics: **Fast**
Deposits: ☒ None ☐ Mud ☐ Sludge ☐ Debris ☐ Grease
Silt Depth: (in.) Deposits Extent:
Infiltration: **None** Pipe Seal Cond: **Sound**
